Appendix G Drainage Survey

Reference	Title
Redwood Environmental	Drainage survey information

Summary Report

RE: Dorset Innovation Park.

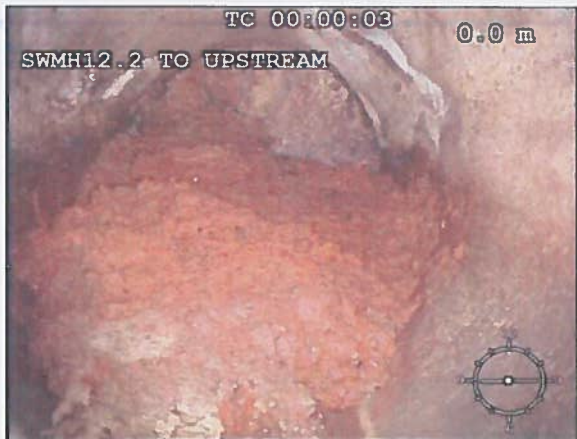
Photo: 4_4a

- Debris at 0.1M.
- Line capped at 0.3M.

0.1m, Debris, 40 % cross-sectional area loss

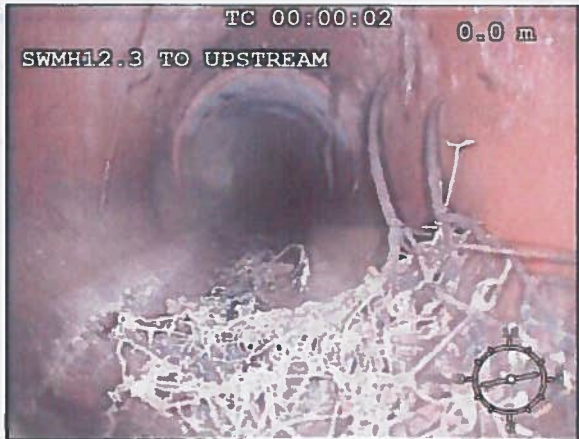
Photo: 15_4a
0.5m, Tap Roots

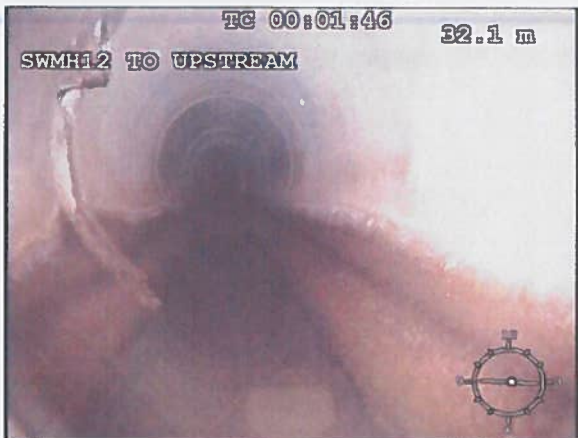
Photo: 26_6a
33m, Connection, at 10 o'clock, dia 100 mm, intrusion 10 %

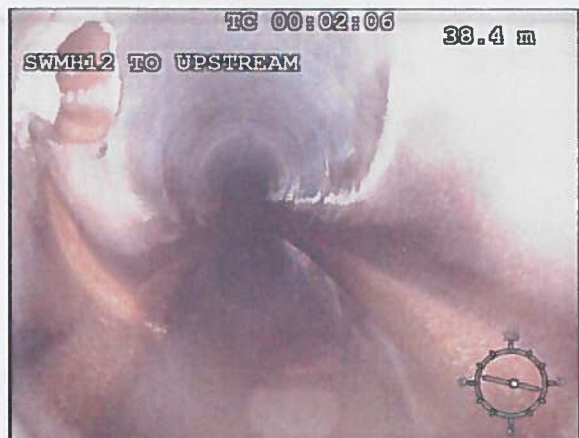
Photo: 27_7a
39.2m, Connection, at 10 o'clock, dia 100 mm, intrusion 10 %

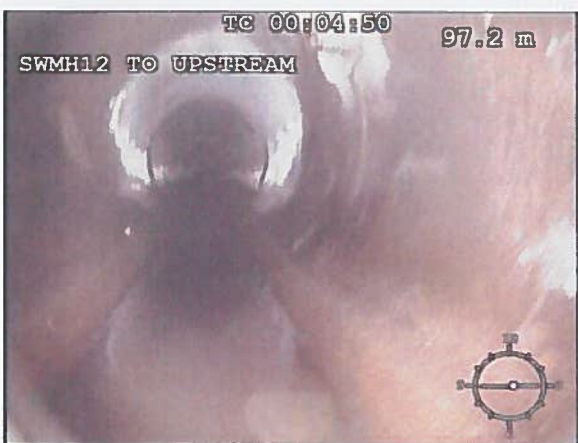
Photo: 28_8a
98.3m, Connection, at 02 o'clock, dia 100 mm, intrusion 5 %

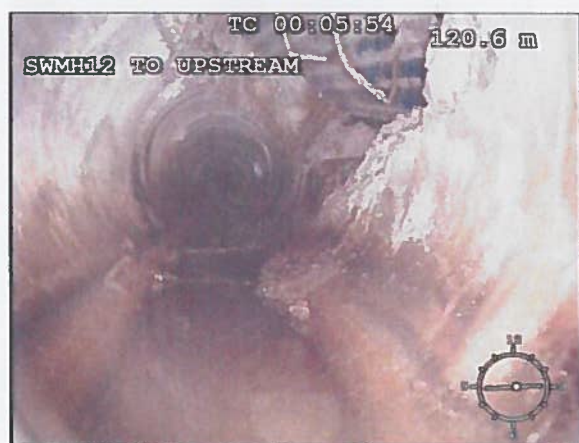
Photo: 30_10a
122m, Sewer Broken, from 12 to 03 o'clock

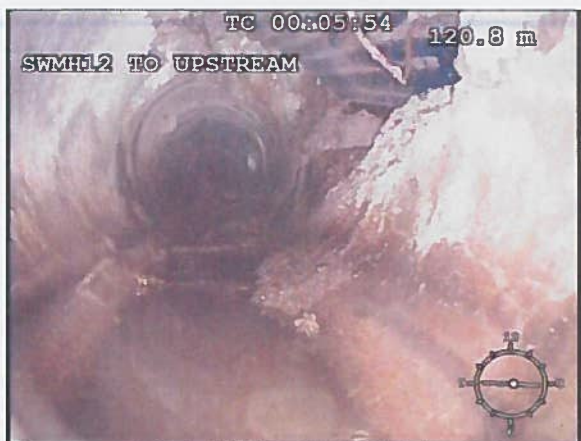
Photo: 31_11a
122m, Hole in sewer from 12 to 03 o'clock

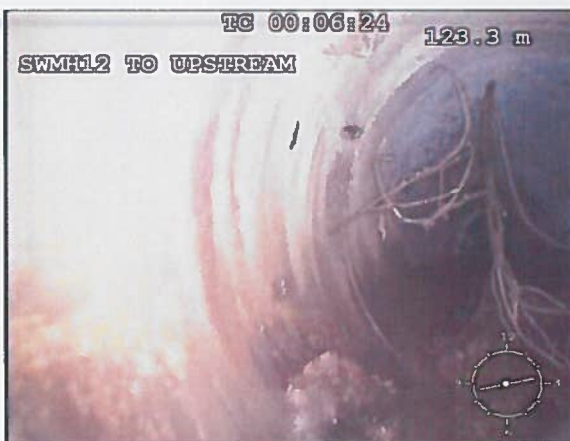
Photo: 32_12a
123.5m, Connection, at 11 o'clock, dia 100 mm, intrusion 10 %

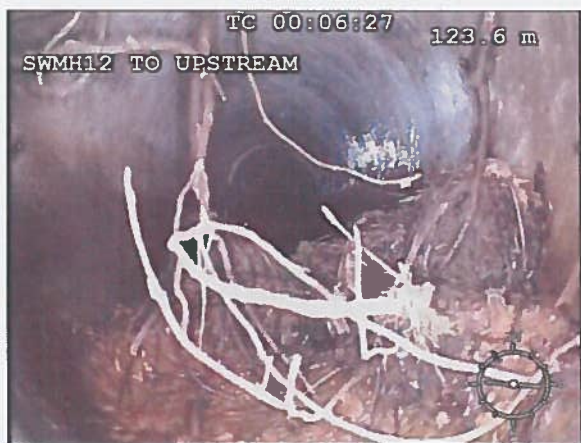
Photo: 33_13a
123.6m, Mass Roots 60 % cross-sectional area loss

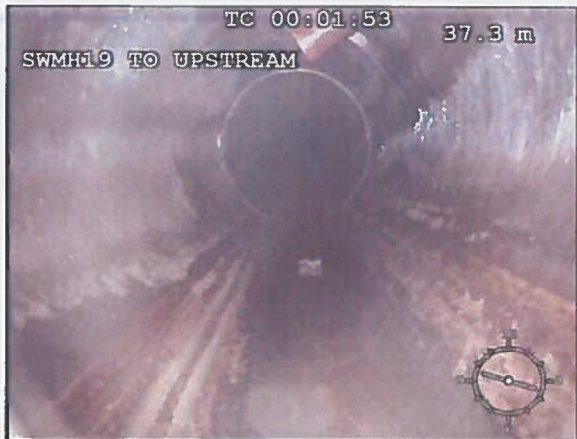
Photo: 43_4a
38.8m, Connection, at 01 o'clock, dia 100 mm, intrusion 10 %

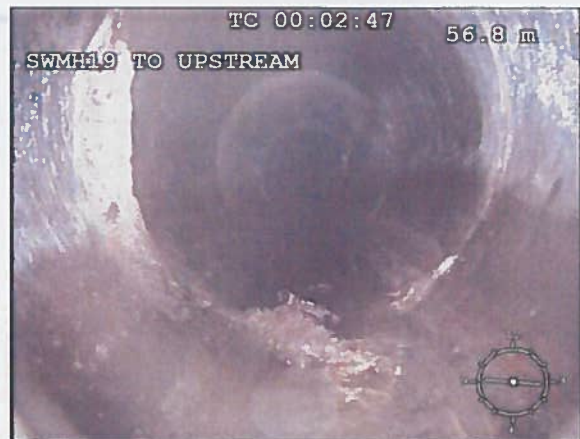
Photo: 44_5a
57.5m, Encrustation medium at joint, from 07 to 11 o'clock, 10% cross-sectional area loss

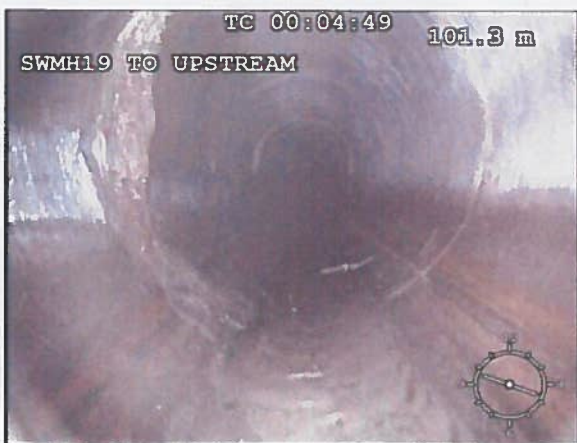
Photo: 45_6a
102m, Encrustation medium at joint, from 08 to 11 o'clock, 10% cross-sectional area loss

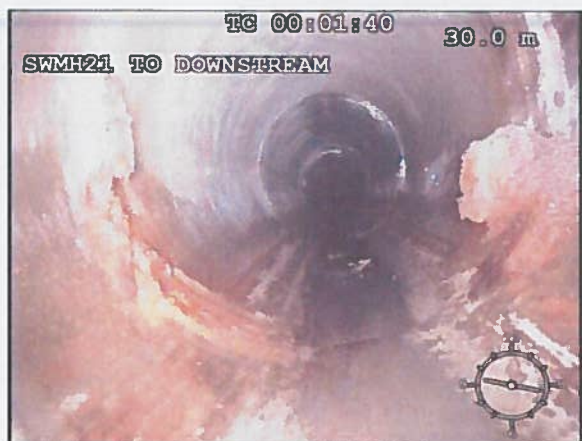
Photo: 52_5a
31m, Encrustation medium at joint, 10% cross-sectional area loss

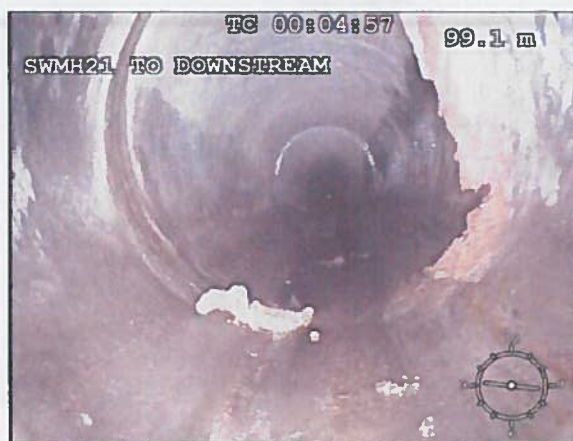
Photo: 53_6a
99.8m, Encrustation heavy at joint, 25% cross-sectional area loss

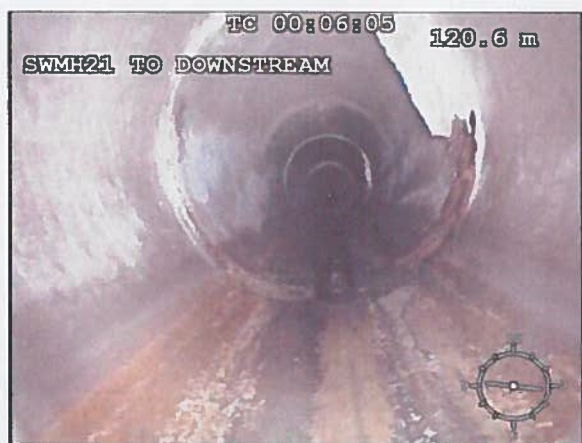
Photo: 56_9a
121.6m, Encrustation heavy at joint, 25% cross-sectional area loss

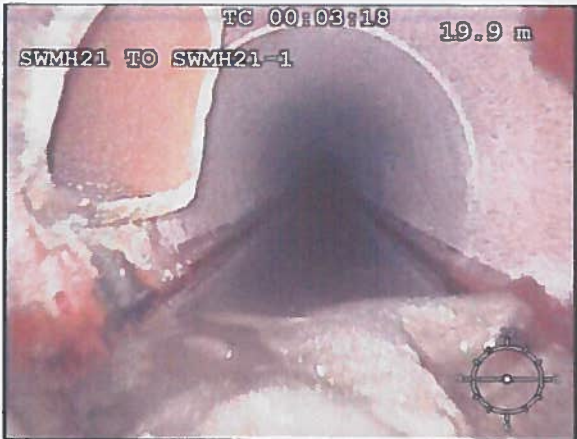
Photo: 77_4a
19.1m, Connection, at 09 o'clock, dia 150 mm, intrusion 20 %

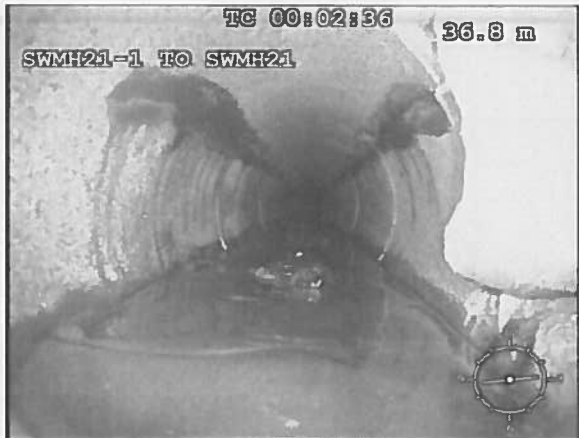
Photo: 82_4a

37.2m, Connection, at 03 o'clock, dia 150 mm, intrusion 20 %

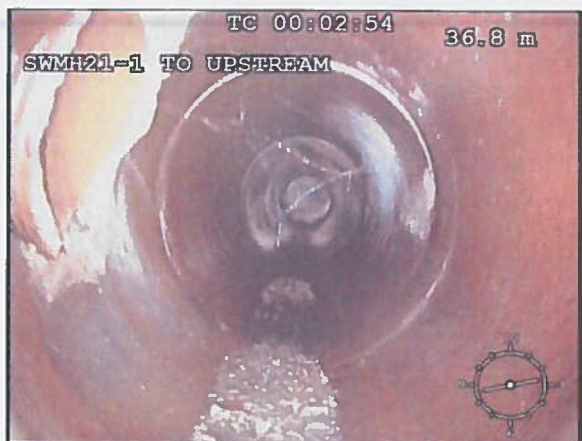
Photo: 87_4a

37m, Connection, at 09 o'clock, dia 100 mm, intrusion 5 %

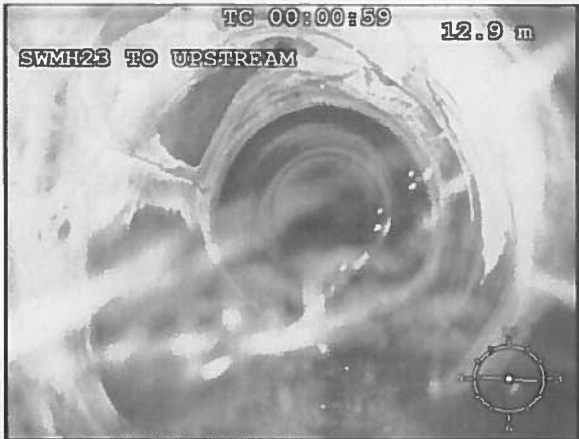
- Multiple fractures at 13M.
- Line capped at 57.1M.

Photo: 92_4a
13m, Multiple Fractures from 12 to 12 o'clock

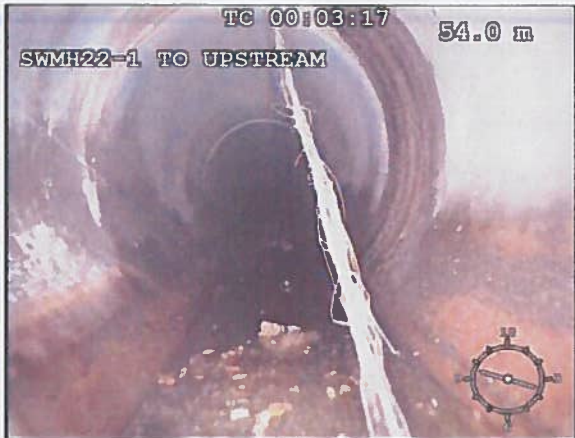
Photo: 106_7a
54.2m, Tap Roots

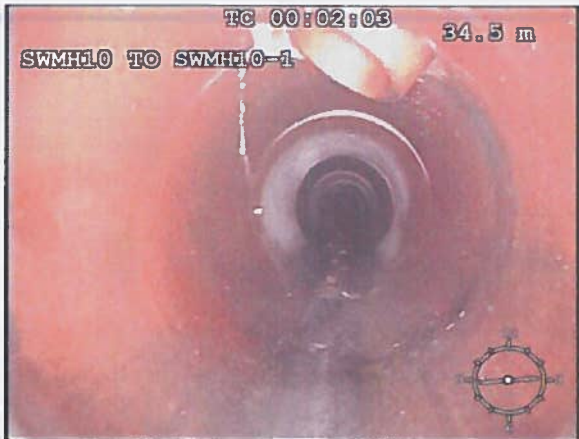
Photo: 117_4a
35m, Connection, at 12 o'clock, dia 100 mm, intrusion 10 %

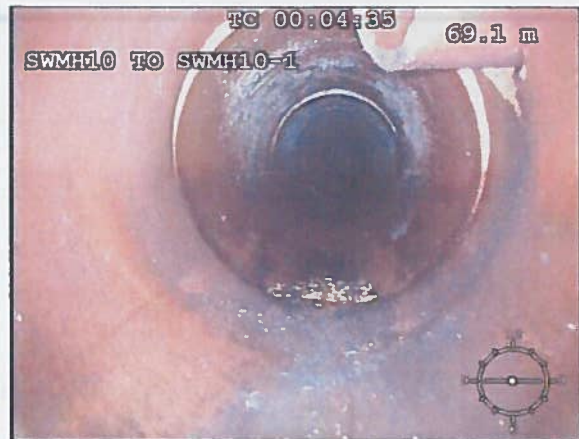
Photo: 118_5a
69.9m, Connection, at 01 o'clock, dia 100 mm, intrusion 15 %

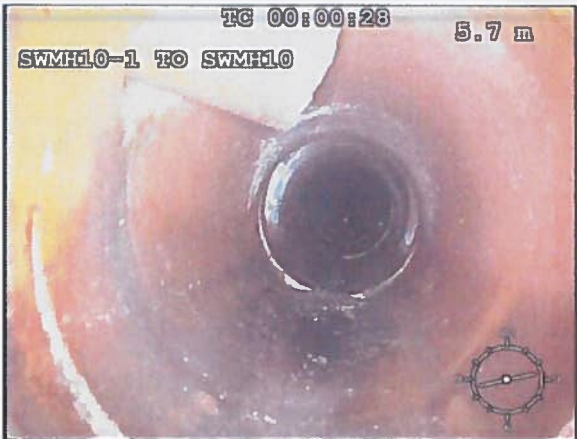
Photo: 123_4a
6.4m, Connection, at 11 o'clock, dia 100 mm, intrusion 15 %

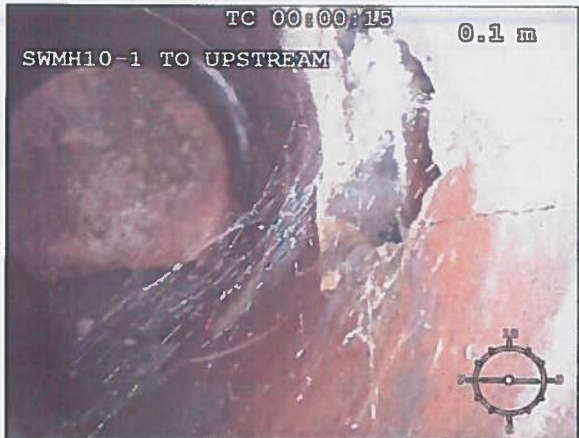
Photo: 128_4a
0.1m, Connection defective, at 03 o'clock, dia 100 mm

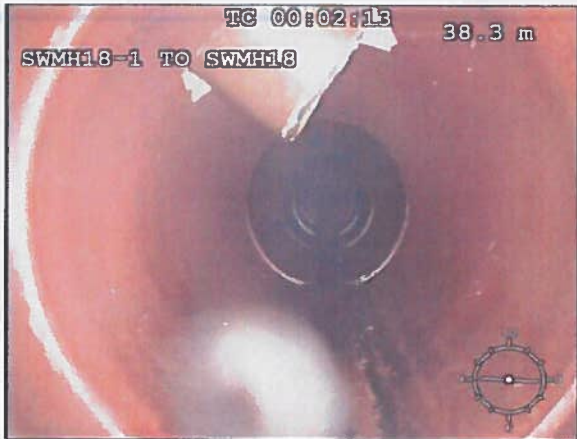
Photo: 133_4a
38.8m, Connection, at 11 o'clock, dia 100 mm, intrusion 10 %

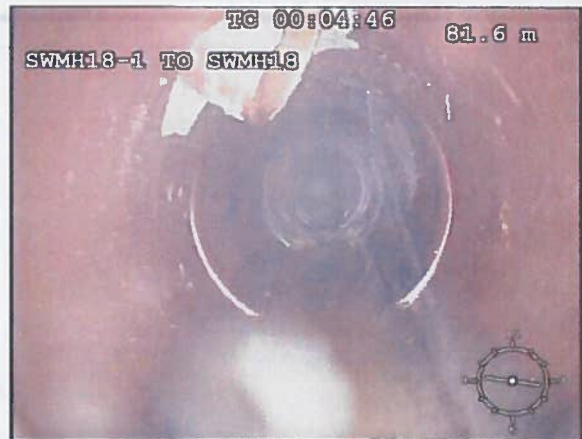
Photo: 134_5a
82.3m, Connection, at 11 o'clock, dia 100 mm, intrusion 10 %

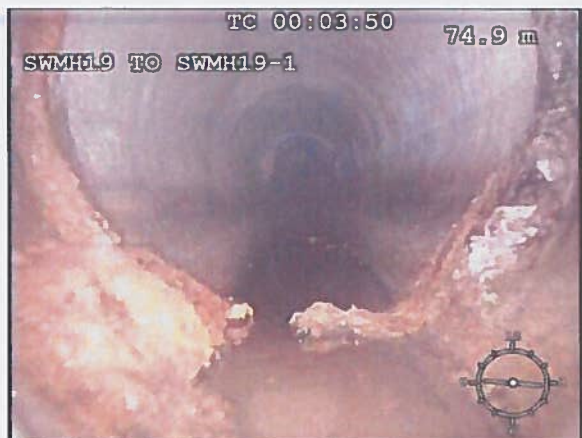
Photo: 141_5a
75.6m, Encrustation medium at joint, 10% cross-sectional area loss

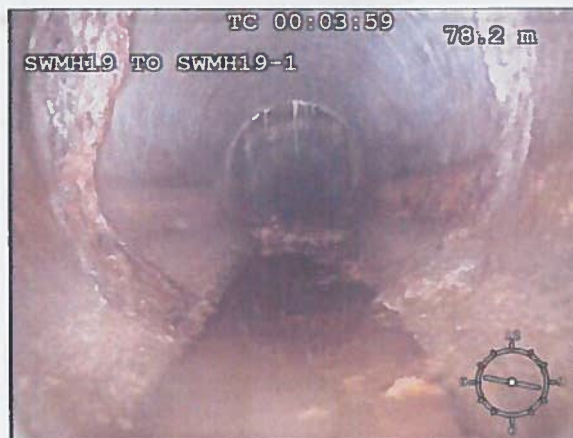
Photo: 142_6a
78.6m, Encrustation medium at joint, 10% cross-sectional area loss

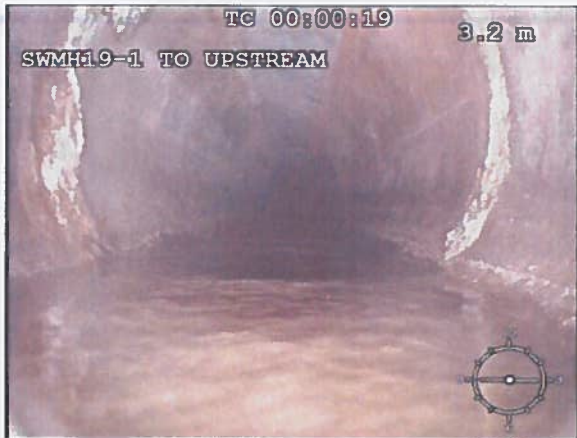
Photo: 148_4a
3.8m, Encrustation medium at joint, 10% cross-sectional area loss

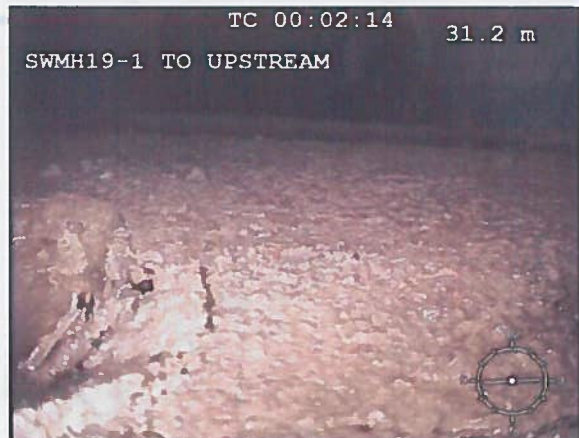
Photo: 150_6a
31.2m, Debris, 40 % cross-sectional area loss

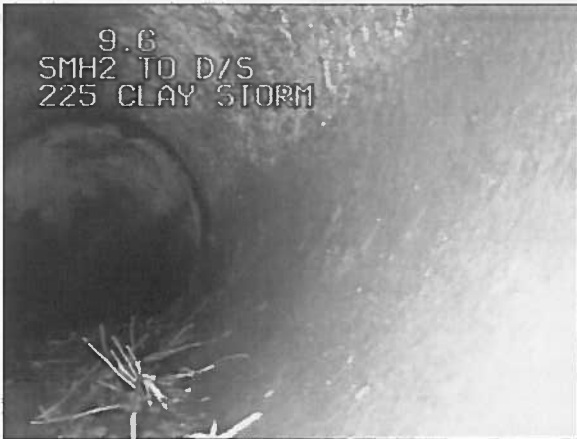
Photo: 257_4a
9.6m, Fine Roots

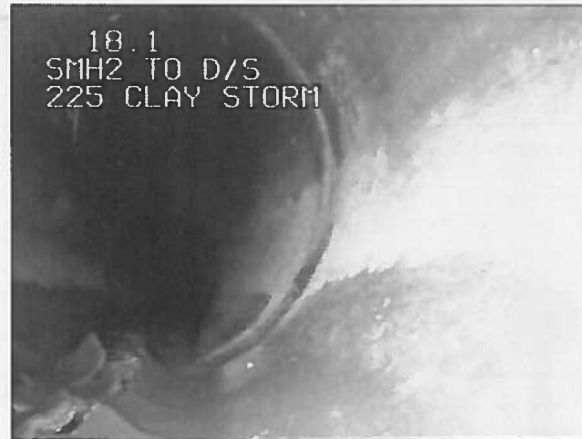
Photo: 258_5a
18.1m, Sewer Broken, at 06 o'clock

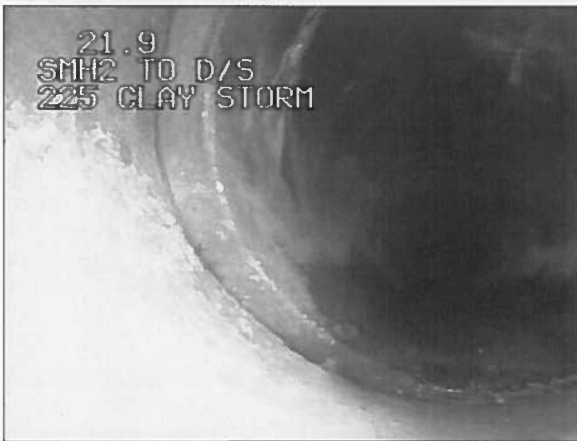
Photo: 259_6a
22.1m, Open joint medium

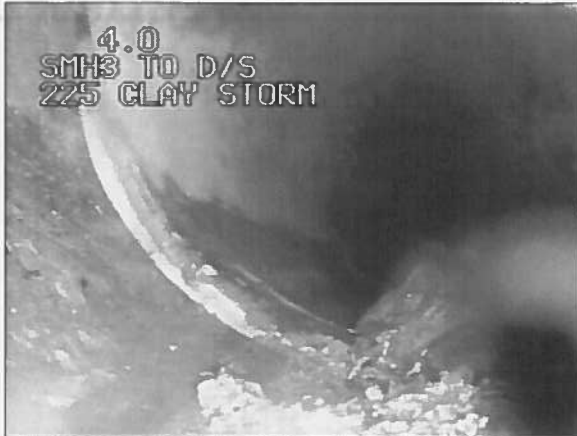
Photo: 265_4a
4m, Debris, 10 % cross-sectional area loss

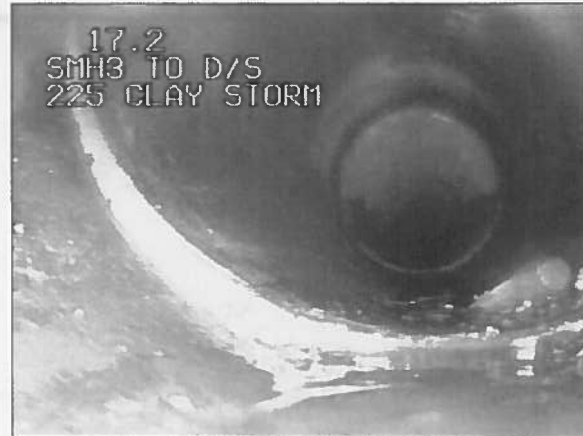
Photo: 266_5a
17.2m, Joint displaced. Medium

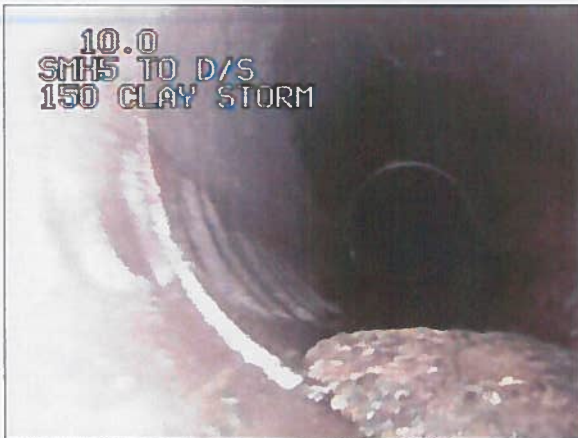
Photo: 271_4a
10.1m, Debris, 10 % cross-sectional area loss

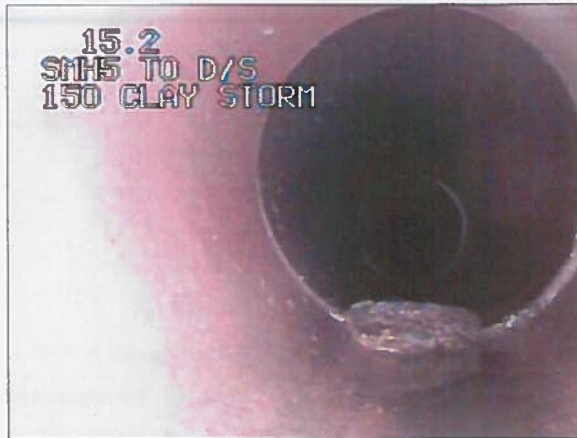
Photo: 272_5a
15.2m, Debris, 10 % cross-sectional area loss

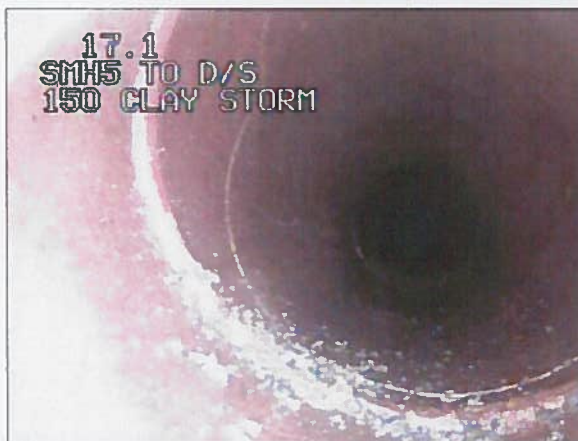
Photo: 273_6a
17.2m, Circumferential Crack, from 03 to 11 o'clock

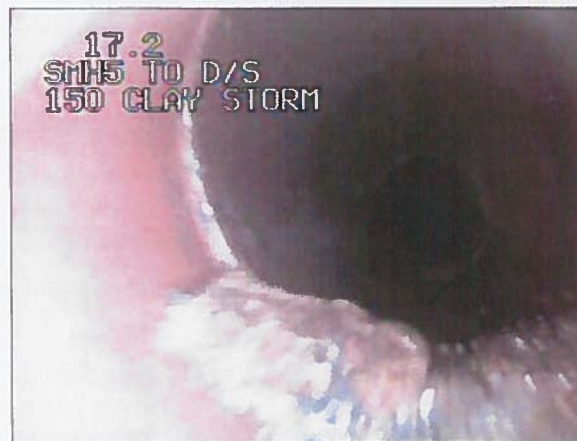
Photo: 274_7a
17.4m, Debris, 10 % cross-sectional area loss

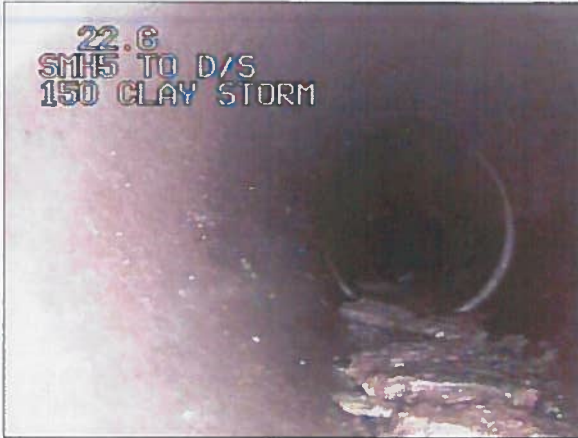
Photo: 275_8a
22.6m, Debris, 10 % cross-sectional area loss

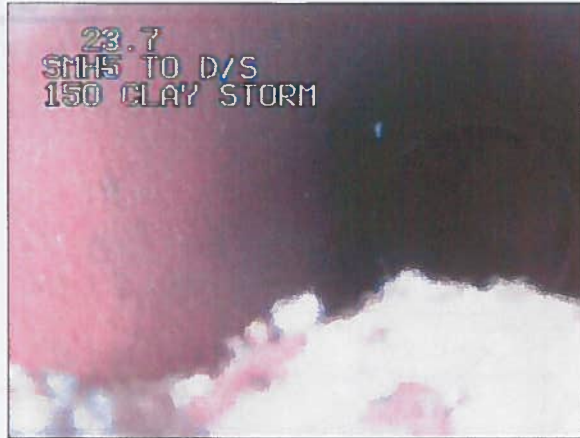
Photo: 276_8a
23.7m, Debris, 20 % cross-sectional area loss

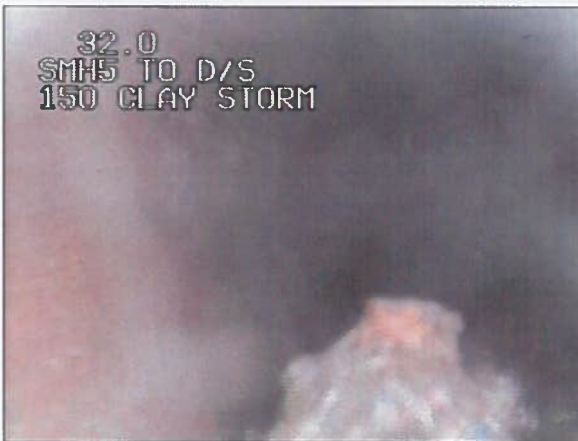
Photo: 277_10a
32m, Debris, 10 % cross-sectional area loss
