Appendix G Drainage Survey

Reference	Title
Redwood Environmental	Drainage survey information

Summary Report

RE: Dorset Innovation Park.

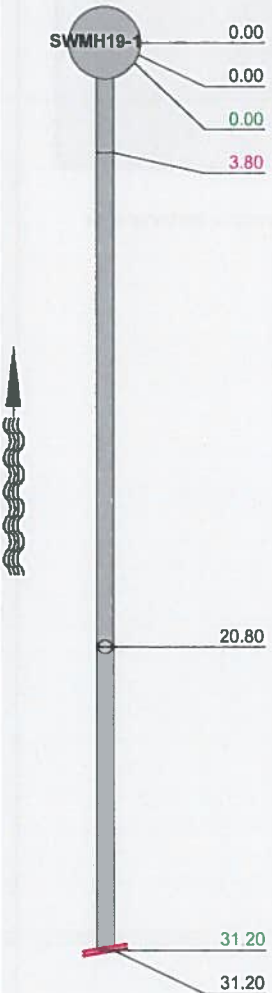
Start of Survey		0
		Manhole Remark: SWMH19-1		0
		Water level, 10 % height/diameter		1
		Encrustation medium at joint, 10% cross-sectional area loss	148_4a	4
		Connection, at 12 o'clock, dia 100 mm		0
		Debris, 40 % cross-sectional area loss	150_6a	1
		Survey abandoned, Remark: Unable to CCTV past debris. Manhole visible		0

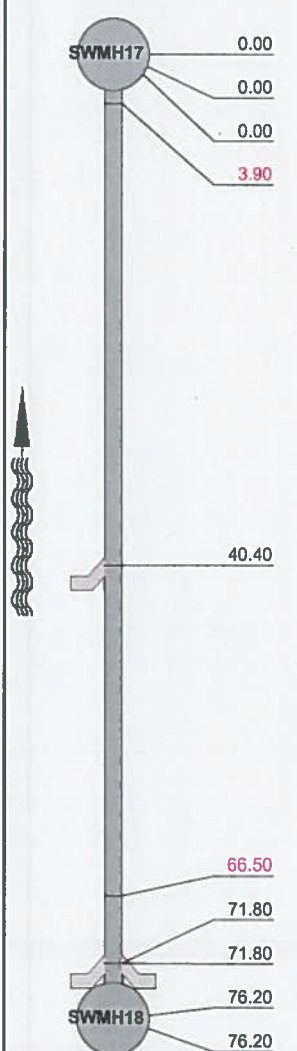
Start of Survey		0
	0.00	Manhole Remark: SMH17		0
	0.00	Water level, 5 % height/diameter		0
	3.90	Encrustation heavy at joint, 25% cross-sectional area loss		5
	40.40	Connection, at 03 o'clock, dia 150 mm		0
	66.50	Encrustation medium at joint, 10% cross-sectional area loss		4
	71.80	Connection, at 03 o'clock, dia 150 mm		0
	71.80	Connection, at 09 o'clock, dia 150 mm		0
	76.20	Manhole Remark: SMH18		0
	76.20	Finish Survey		0
